METALS HANDBOOK

VOL. 9
FRACTOGRAPHY AND ATLAS OF FRACTOGRAPHY

8th EDITION

Fractography and Atlas of Fractographs

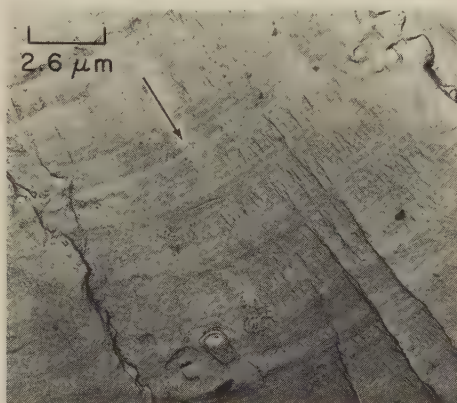
TEM fractograph (p-c replica) 3900×
Fig. 44. "Brittle" fatigue striations on a fracture surface of aluminum alloy 7075-T6 exposed to a corrosive environment. Arrow indicates fracture direction.

Occasionally, distinction is made between "ductile" and "brittle" striations observed on the surfaces of fatigue fractures in aluminum alloys. Ductile striations (Fig. 43) are more commonly observed than brittle striations (Fig. 44). In Fig. 45, note that the brittle striations appear to combine the features of cleavage (steps) and fatigue (striations that appear very flat). Generally, brittle striations can be attributed to the effect of an environmental factor acting at the crack

front. For example, the fatigue fracture shown in Fig. 44 is the result of crack propagation in aluminum alloy 7075-T6 in a corrosive environment. Similarly, secondary cracking at the fatigue striations is observed in some alloys (Fig. 46). Brittle striations are usually observed where crack-propagation rates are slow enough to allow the environmental interaction to occur ahead of the moving crack. At higher crack-growth rates, the speed of crack propagation appears to be faster than the diffusion rate of the embrittling species, and ductile striations are produced (Ref 11). A further complication introduced with a corrosive environment is the deposition or growth of corrosion products on fracture surfaces, which will mask fatigue striations (Fig. 47).

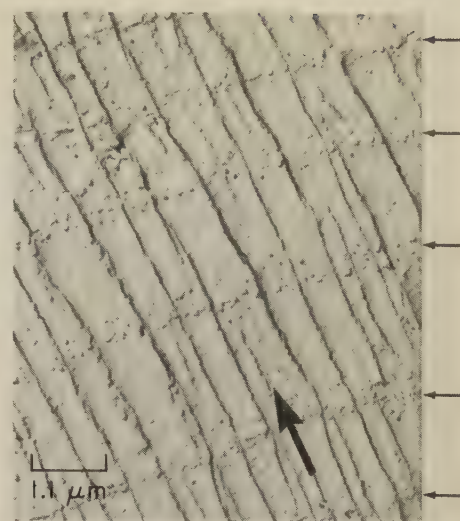
TEM fractograph (p-c replica) 8700×
Fig. 45. "Brittle" fatigue striations (at horizontal arrows) on an apparently cleaved fracture surface of a magnesium alloy AZ91-T6 casting. Arrow on fractograph shows direction of crack growth.

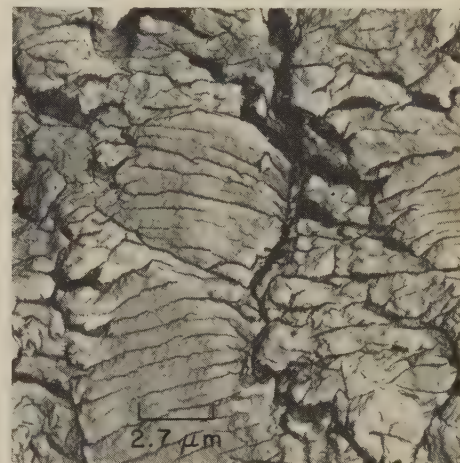
TEM fractograph (p-c replica) 3750×
Fig. 46. Secondary cracking at fatigue striations on a fracture surface of titanium alloy Ti-6Al-4V exposed to a hydrogen atmosphere at room temperature

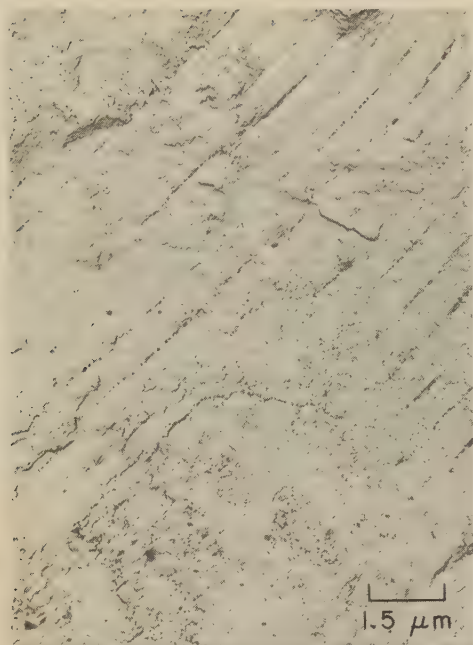
TEM fractograph (p-c replica) 6500×
Fig. 47. Masking effect of corrosion products on fatigue striations on a fracture surface of aluminum alloy 7075-T6

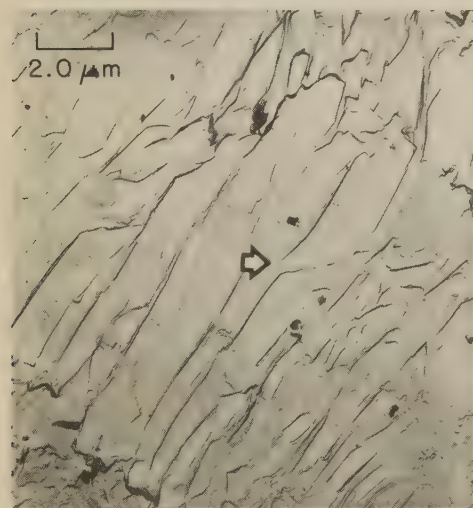
TEM fractograph (p-c replica) 4900×
Fig. 48. Tension-overload fracture in an aluminum alloy 7075-T6 spot-weld nugget. The lamellar structure, which is forked (arrow), could be confused with fatigue striations.

With alloys that have a regularly spaced lamellar structure of intermetallic phases, fracture surfaces sometimes have features that resemble fatigue striations. The fracture shown in Fig. 48 was produced in tensile testing of an aluminum alloy 7075-T6 spot-weld nugget. The fracture shows a lamellar structure of eutectic particles that might be confused with fatigue striations. Unlike fatigue striations, however, the eutectic particles

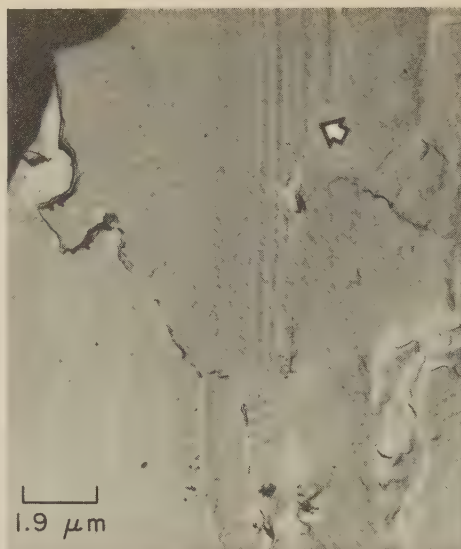
TEM fractograph (p-c replica) 5400×
Fig. 49. Rub marks (at arrow) on the surface of a fatigue fracture in aluminum alloy 7075-T6

Rub marks, which may consist of sets of parallel lines (Fig. 49), are commonly observed on fatigue fractures, especially when the cyclic stress has a compressive component. Like tire tracks, rub marks are not fatigue striations but indicate mechanical damage. Because they have been seen in fractures resulting from a single load application (Fig. 50), they are not reliable indicators of fatigue.

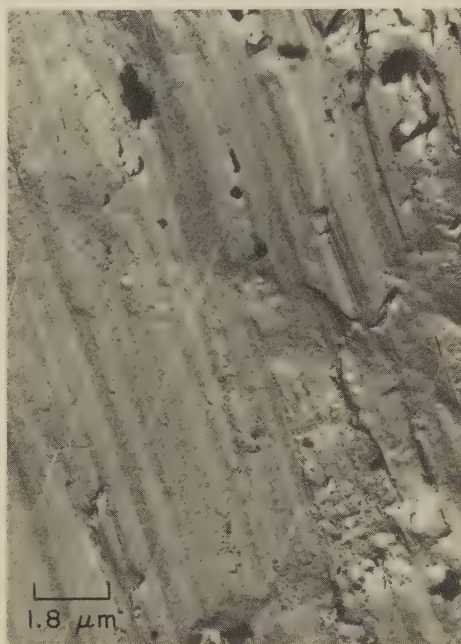
TEM fractograph (p-c replica) 5600×
Fig. 50. Rub marks on an overload-fracture surface of AMS 6265 (9310) steel. The light lines are cracks in the replica.

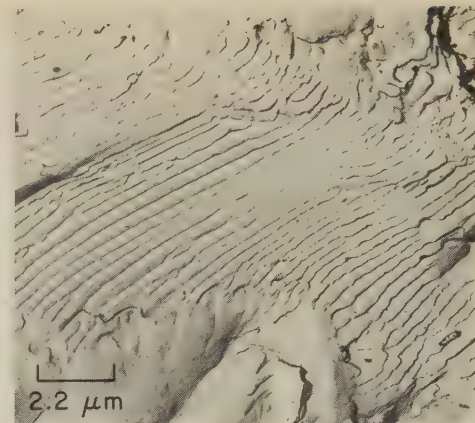
Fig. 51. Lamellar pearlite platelets on a fatigue-fracture surface of gray iron

TEM fractograph (p-c replica) 4560×
No fatigue striations were observed anywhere on the fracture surface. Penetration of platelets into the surrounding matrix shows that they are pearlite platelets, not fatigue striations.

Other examples of fracture features that resemble fatigue striations are shown in Fig. 51, 52 and 53; these are:

- 1 The lamellar structure created by a pearlite colony in gray iron (Fig. 51)
- 2 The lamellar array of steps on a fracture surface of forged titanium alloy Ti-6Al-4V that resulted from the differences in the amount of flow of the alpha and beta phases that occurred during forging (Fig. 52)
- 3 Scratch-mark artifacts on a plastic replica that were produced by contact with promontories of the fracture surface during stripping (Fig. 53).

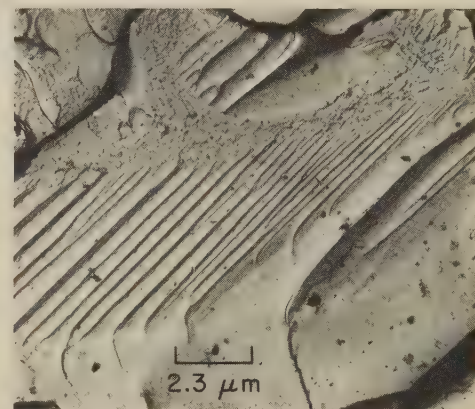
Fig. 52. Lamellar array of steps on a fracture surface of a titanium alloy Ti-6Al-4V forging

TEM fractograph (p-c replica) 4400×
The steps, which formed at acicular alpha platelets, resulted from the differences in amount of flow of the alpha and beta phases that occurred during forging. Note that the steps penetrate into the surrounding matrix, which shows that they are not fatigue striations.

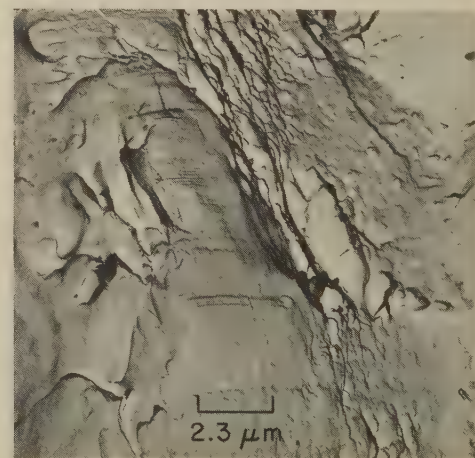
TEM fractograph (p-c replica) 4400×
Fig. 53. Scratch-mark artifacts on a plastic replica, produced by contact with promontories of the fracture surface during stripping. These marks, reproduced on the second-stage (carbon) replica, bear a resemblance to fatigue striations.

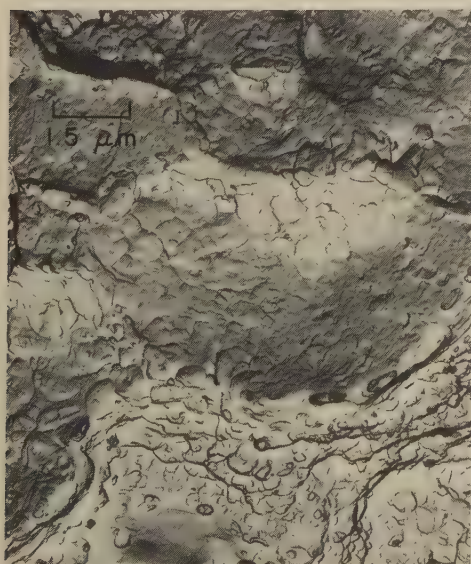
TEM fractograph (p-c replica) 6500×
Fig. 54. Grain-boundary fracture in aluminum alloy 7075-T6 showing very shallow dimples, which resulted from microvoid coalescence, on the grain surfaces

In some instances, intergranular fracture will show evidence of microvoid coalescence within a very small layer of metal at the grain interfaces. High-strength aluminum alloys frequently fracture by grain-boundary separation with microvoid coalescence (Fig. 54). It has been postulated that the fracture proceeds along alloy-depleted zones in the grain boundaries, which are soft in comparison with the matrix. This is a brittle fracture in the macroscopic sense and plastic in the microscopic sense. Many intergranular fractures, such as those caused by hydrogen embrittlement, stress corrosion, brittle grain-boundary phases,

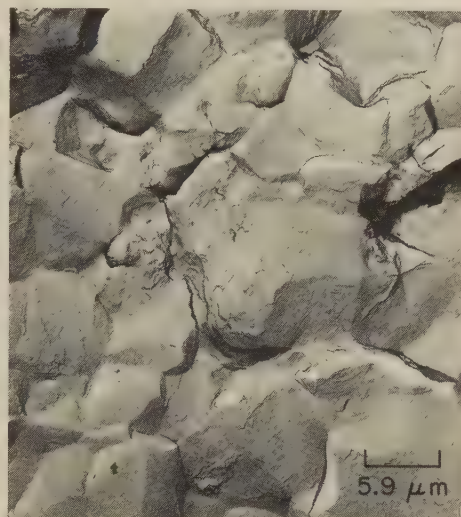
TEM fractograph (p-c replica) 1700×
Fig. 55. Intergranular fracture in 4340 steel with a tensile strength of 1795 to 1930 MPa (260 to 280 ksi), showing equiaxed grains that have separated without microvoid coalescence; a "rock candy" fracture surface

quench cracking, and grinding cracks, show little or no evidence of microvoid coalescence; they have a "rock candy" appearance (Fig. 55).

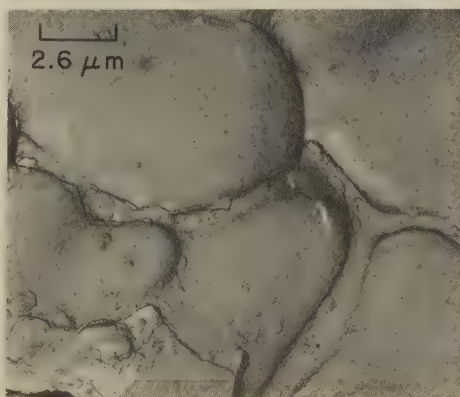
TEM fractograph (p-c replica) 3900×
Fig. 56. Intergranular fracture along a cored (segregated) grain-boundary network in a weld of aluminum alloy 2014-T6. No evidence of microvoid coalescence.

In interdendritic fracture of welds and castings (Fig. 56), features have a more rounded appearance, but the fractures are classified as intergranular. Fractures that occur along flattened grains (typical of parting planes in forgings) are virtually featureless (Fig. 57), because of the low angles between adjacent grains. If the shadowing angle used during replication is lessened, features will be brought into greater relief when examining these fractures.

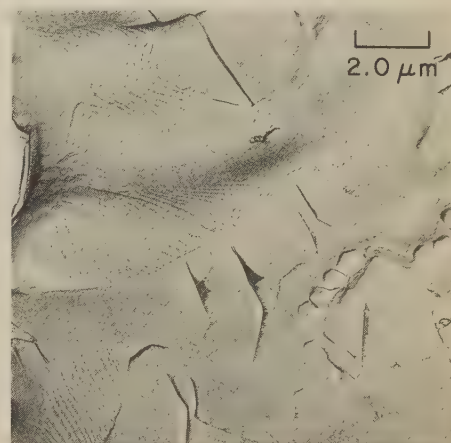
TEM fractograph (p-c replica) 4900×
Fig. 58. Geometric patterns exposed by a fracture through a porous weld in aluminum alloy 2014

Geometric patterns are commonly observed in the fracture surfaces of welds and castings. These patterns are found in areas of voids and porosity, and are typical of the solidification and growth of a free surface from a melt (Fig. 58 and 59). Fractures through some material imperfections, such as hydrogen flakes in steel (see fractographs 4344 and 4345, on page 312) and unhealed porosity in aluminum

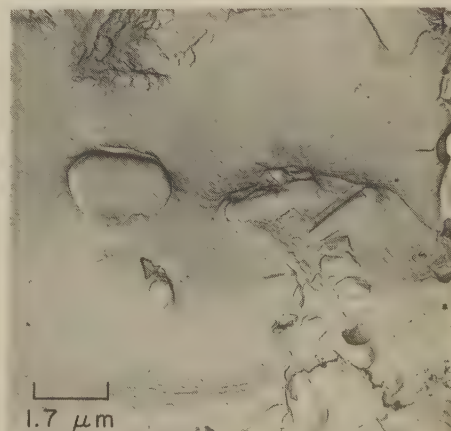
TEM fractograph (p-c replica) 5900×
Fig. 59. Geometric patterns exposed by a fracture through a cavity in an aluminum alloy 356-T6 casting

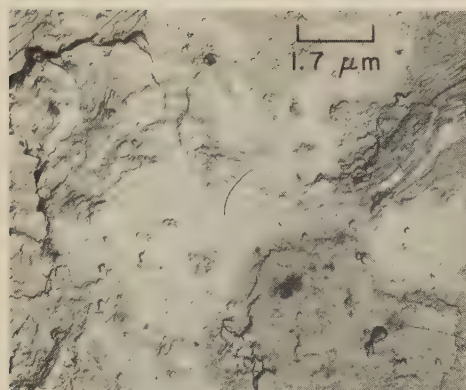
TEM fractograph (p-c replica) 5900×
Fig. 60. Geometric patterns exposed by a fracture through unhealed porosity in an aluminum alloy 2014-T6 forging

forgings (Fig. 60), have the same appearance. The latter are not true intergranular fractures, but are significant because they represent fracture through a loosely bonded, or an unbonded, interface.

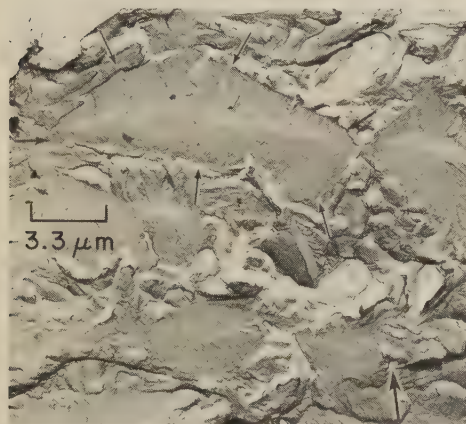
Fig. 61. Fracture surface of titanium alloy Ti-6Al-4V broken by stress-corrosion cracking in methanol (Ref 12)

TEM fractograph (p-c replica) 3000×
Fracture surface shows cleavage facets and dimples. The small arrows enclose an isolated cleavage facet. The large arrow indicates the direction of macroscopic crack propagation.

ratio of the areas that fractured by cleavage to those that fractured by microvoid coalescence is directly related to the level of stress intensity at the tip of the propagating crack. Figure 61 shows the fracture surface that developed when titanium alloy Ti-6Al-4V was stressed in methanol at room temperature. The alloy had been solution annealed, quenched and aged at 538 C (1000 F) to develop a yield strength of 1070 MPa (155 ksi). The fracture surface (see Fig. 61) consists of large, flat cleavage facets interconnected by areas of dimples. The cleavage facets show tear ridges and river patterns corresponding to the joining together of cracks propagating at different levels along the main fracture plane. The small arrows in Fig. 61 enclose an isolated cleavage facet; the large arrow indicates the direction of macroscopic crack propagation.

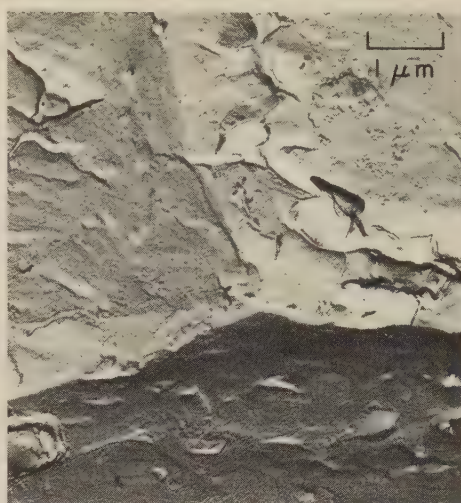
TEM fractograph (p-c replica) 10,000×
Fig. 62. Intergranular fracture surface of 4340 steel. Fracture was caused by stress-corrosion cracking in 3 1/2% NaCl solution.

In Fig. 62, linear marks are visible on the surface of a fracture produced by stressing in a sodium chloride solution a specimen of 4340 steel that had been quenched and tempered to a yield strength of 1380 MPa (200 ksi). Because all of the marks appear as ridges extending above the grain facets when viewed using stereo techniques, they are believed to be associated with the final tearing apart of small uncracked ligaments on the grain surfaces. Evidence of ductility is limited to a very narrow layer on either side of the grain boundary at which separation occurred.

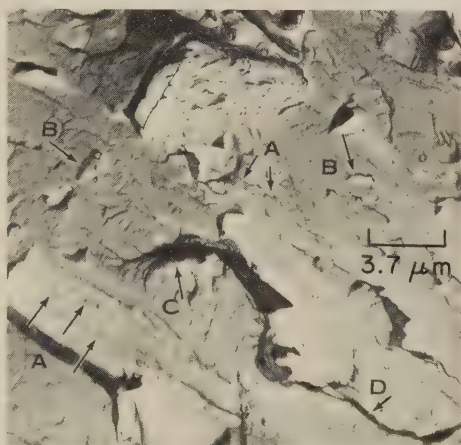
Fig. 63. Transgranular-cleavage fracture in a specimen of 4315 steel, showing tear ridges (A), tongues (B), shallow dimples (C), and secondary cracks (D) (Ref 13)

TEM fractograph (p-c replica) 2680×
Fracture was caused by stress-corrosion cracking in a 3 1/2% NaCl solution. Stress intensity at the tip of the crack in this region of fracture was low. See also Fig. 64, on the opposite page.

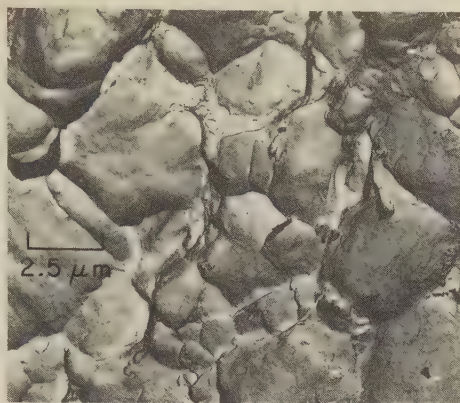
Fig. 64. Dimples resulting from microvoid coalescence on the fracture surface of the specimen of 4315 steel in Fig. 63 (Ref 13)

TEM fractograph (p-c replica) 3960×
Fracture was caused by stress-corrosion cracking in a 3½% NaCl solution. Stress intensity at the tip of the crack in this region of fracture was high—95% of the plane-strain fracture toughness (K_{Ic}) of the material.

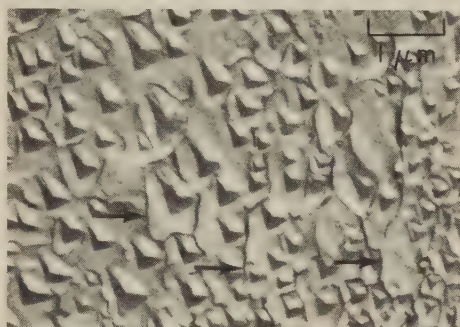
TEM fractograph (p-c replica) 10,000×
Fig. 65. Fracture around precipitates in a grain-boundary surface in maraging steel with a yield strength of 1725 MPa (250 ksi). Note the tear ridges (as at arrows). Fracture was by hydrogen embrittlement during stressing. (Ref 14)

An example of intergranular separation in high-strength steels from environmental embrittlement is shown in Fig. 65. A maraging steel with a yield strength of 1725 MPa (250 ksi) was stressed while being electrolytically charged with hydrogen in a bath of 3½% NaCl and water. The single grain-boundary facet shown is covered with a large number of intergranular precipitates. In several areas, tear ridges can be observed; these are associated with cracking around the precipitate particles. The tear ridges were formed when the cracks that were initiated as the result of hydrogen charging grew together.

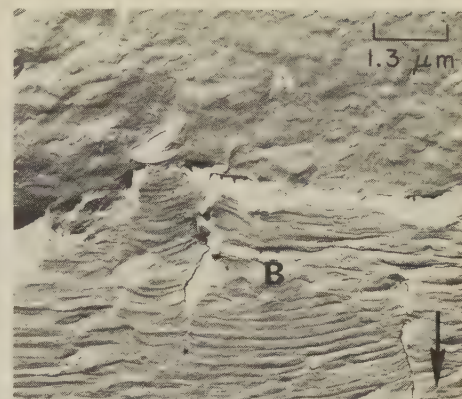
Fig. 66. Fatigue fracture in aluminum alloy 2024-T3 tested first in vacuum (region A) and then in air (region B) (Ref 15)

TEM fractograph (p-c replica) 7500×
Stress amplitude was low, but higher than for the fracture shown in Fig. 67. Arrow, at lower right, indicates direction of crack propagation.

In contrast, the regular fatigue striations produced by fracture while testing in air (region B in Fig. 66) correlate with the crack advance of each loading cycle. The striations resulted from the plastic deformation that occurred at the crack tip as the crack was opened during the tensile portion of the load cycle.

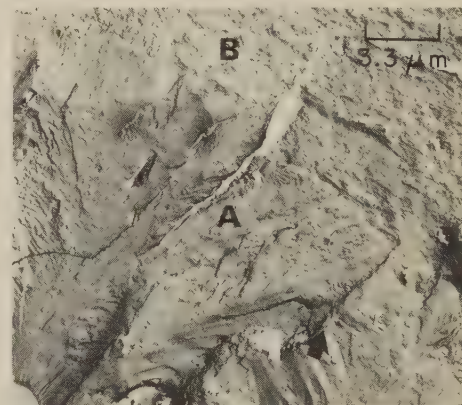
Fig. 67. Fatigue fracture in aluminum alloy 2024-T3 tested first in air (region A) and then in vacuum (region B) (Ref 15)

TEM fractograph (p-c replica) 3000×
Stress amplitude was much lower than for the fracture shown in Fig. 66. Flat fatigue striations would be visible in region A by stereoscopic examination or at a higher magnification. Arrow, at bottom, indicates direction of crack propagation.

Figure 67 shows the fracture surface of a specimen of aluminum alloy 2024-T3 that was fatigue tested in air and in vacuum at a much lower stress amplitude than the specimen of Fig. 66. At this low stress amplitude, the plasticity producing fatigue striations in the portion tested in air (region A in Fig. 67) is less and the striations are very flat, leaving an impression of transgranular cleavage when viewed at this magnification. This region exhibits linear features that resemble tear ridges and fine river patterns.

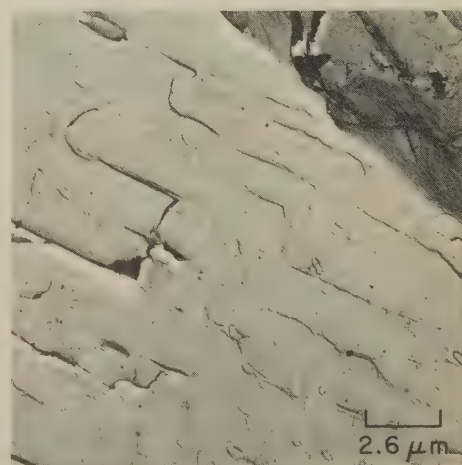
TEM fractograph (p-c replica) 3900×
Fig. 68. Transgranular cleavage facets on a corrosion-fatigue fracture surface of titanium alloy Ti-8Al-1Mo-IV tested at a frequency of ½ cycle per second in a 3½% NaCl solution at crack-growth rates ranging from 20 to 200 micro-in. per cycle. Compare Fig. 69. (Ref 16)

and 69 show fracture surfaces obtained from specimens of titanium alloy Ti-8Al-1Mo-1V tested in a 3 1/2% NaCl solution at amplitudes producing crack-growth rates ranging from 20 to 200 micro-in. per cycle for Fig. 68 and in excess of 200 micro-in. per cycle for Fig. 69. The appearance of the fracture surface in Fig. 68 is typical of stress-corrosion cracking in this alloy; transgranular cleavage predominates. The fine detail on the cleavage facets is related to the two-phase microstructure of the alloy. At high amplitudes (Fig. 69), the fracture surface consists of coarse fatigue striations and rugged cleavage facets.

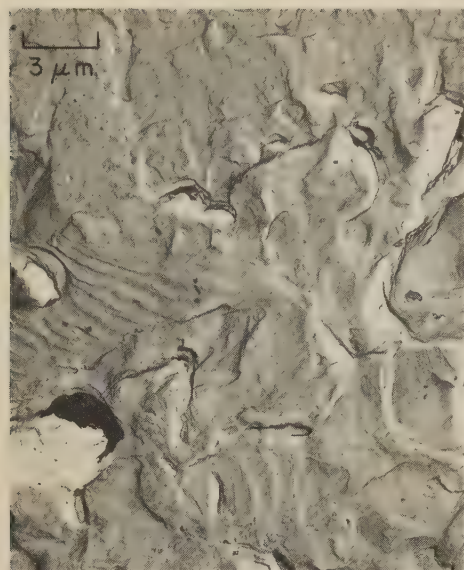
TEM fractograph (p-c replica) 3300×
Fig. 69. Coarse fatigue striations and rugged cleavage facets on a corrosion-fatigue fracture surface of titanium alloy Ti-8Al-1Mo-1V tested at a frequency of 1/2 cycle per second in a 3 1/2% NaCl solution at crack-growth rates of over 200 micro-in. per cycle. Compare Fig. 68. (Ref 16)

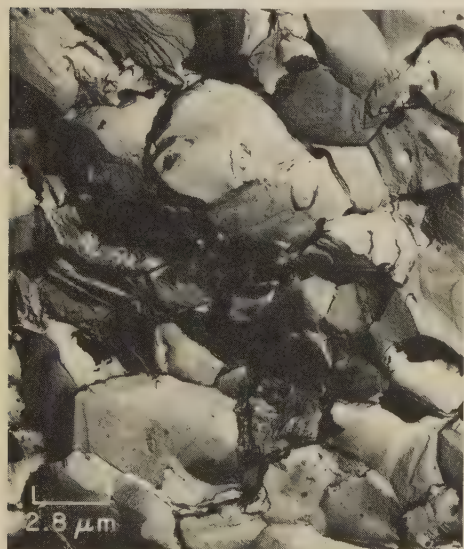
TEM fractograph (p-c replica) 3600×
Fig. 70. Mixture of separated-grain facets and transgranular cleavage facets on the surface of a fracture in titanium alloy Ti-6Al-4V that was exposed to solid cadmium at 149 C (300 F) (Ref 17)

Embrittlement by Liquid and Solid Metals. Liquid-metal environments have been known to cause cracking of some alloys. A metal in the solid state can have a similar effect. The resulting fracture path can be either transgranular or intergranular, depending on the alloy, its microstructure, and the nature of the environment. Figure 70 shows a fracture surface of a specimen of solution treated and aged titanium alloy Ti-6Al-4V that cracked after exposure to solid cadmium at 149 C (300 F). The fracture occurred by a mixture of intergranular cracking and transgranular cleavage.

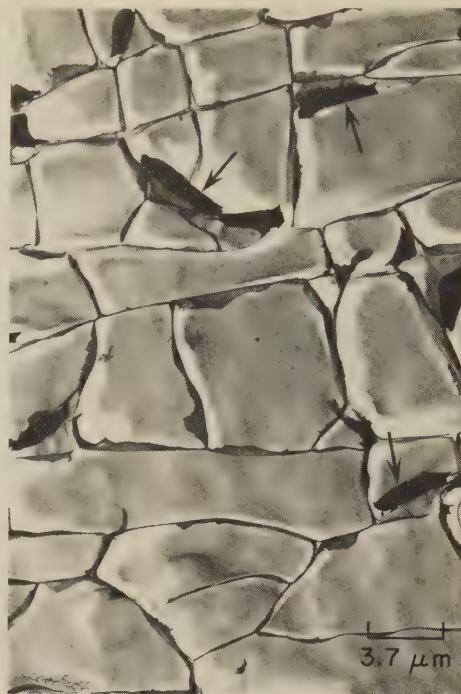
Fig. 71. Mud-crack pattern on the surface of an intergranular fracture in aluminum alloy 7079-T651 caused by stress-corrosion cracking in a 3 1/2% NaCl solution (Ref 18)

TEM fractograph (p-c replica) 2700×
Mud-crack pattern resulted from replication of corrosion products that adhered to the surface and obscured it. Black patches, such as at arrows, are corrosion debris that were lifted off the fracture with the first-stage replica.

are not tightly bound to the fracture surface, they can be incorporated in and removed by the replica. If corrosion products are not removed with the replica, their exposed surfaces will be replicated, producing artifacts that will interfere with fracture-surface analysis. Figure 71 shows corrosion products that formed on the fracture surface of aluminum alloy 7079-T651 after stress-corrosion cracking in a 3 1/2% NaCl solution. The black angular patches are corrosion debris lifted off the fracture with the first-stage plastic replica. The mud cracks and flat facets represent areas where the corrosion products remained on the surface of the separated-grain facets and were replicated.

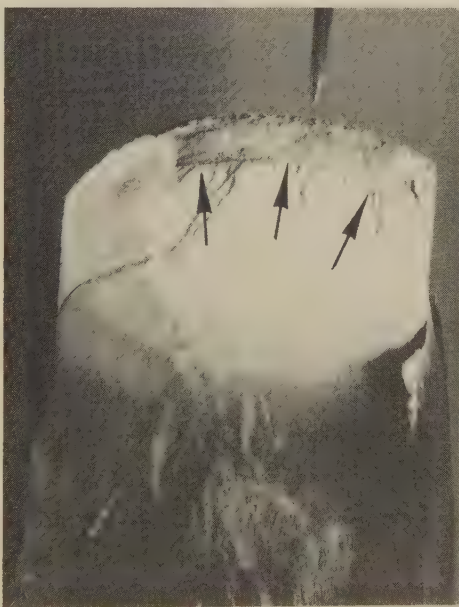
Fig. 1. Fatigue fracture that propagated from a seam in the counterbalance cheek of a forged 1046 (mod) steel crankshaft

Light fractograph 4.2×
The seam was in the area between the fracture edge indicated by the pointer and the line indicated by the arrows. Hardness of the steel was 255 Bhn.

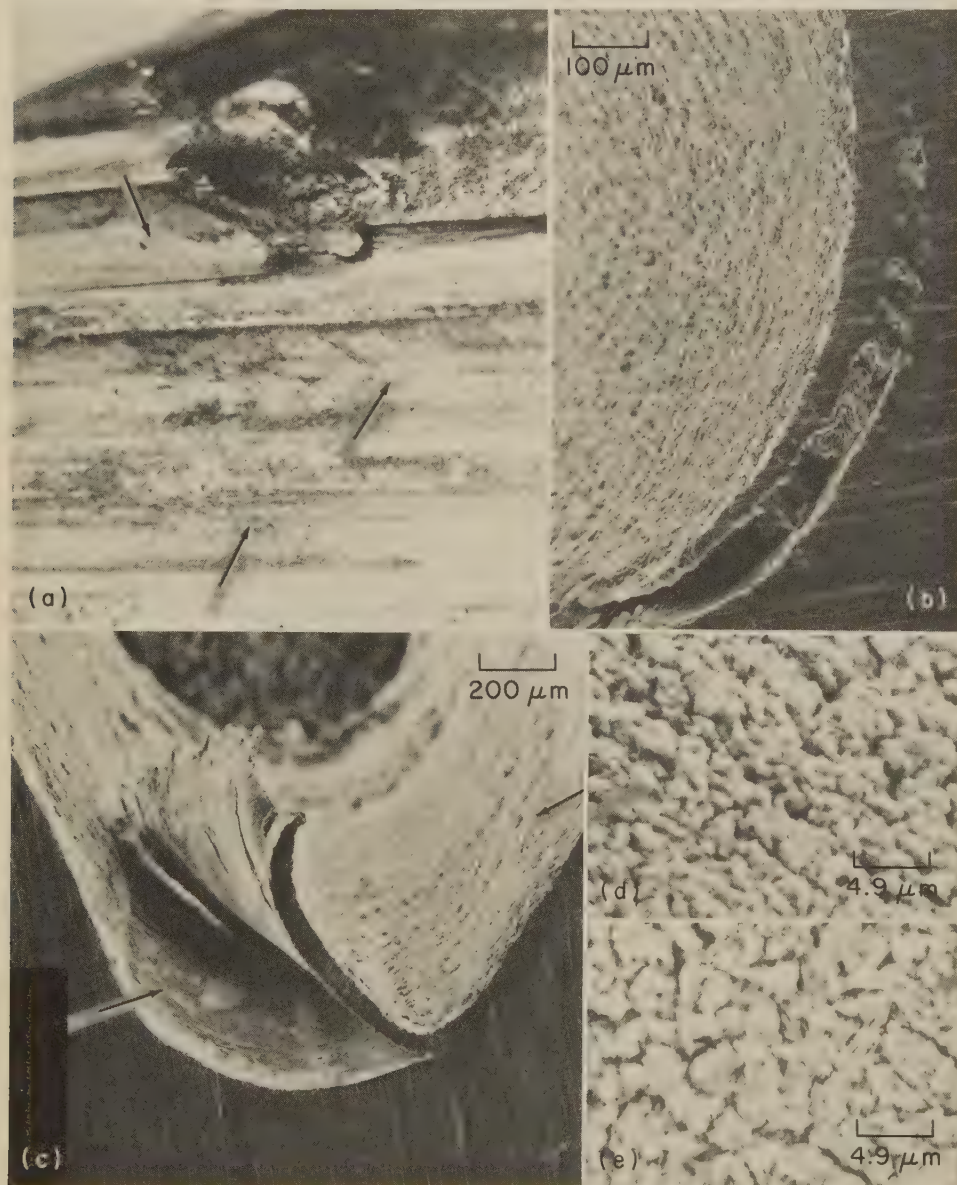
(a) Light fractograph, at 10X, showing laps (at arrows). (b) SEM fractograph, at 100X, giving detail of a lap. (c) SEM fractograph, at 50X, showing heavily oxidized surfaces of a lifted lap; the oxidation indicates that the lap was present before heat

treatment of the stud. Arrow at right points to area shown in fractograph (d), and arrow at left points to area shown in fractograph (e).

(d) and (e) SEM fractographs showing oxidized surfaces of the lifted lap in fractograph (c) at 2040X.

Fig. 2. Laps formed during thread rolling of a 300M steel stud. See Fig. 3 for views of the stress-corrosion crack initiated by the laps.

Figure 2 demonstrates the depth of field and general utility of the scanning electron microscope at low magnification for identifying discontinuities such as seams and laps. The fractographs in Fig. 2 show laps that had been rolled into the thread roots of a 300M steel stud during thread rolling. The laps served as origins of a stress-corrosion crack that partly severed the stud. Both surfaces of a lifted lap (Fig. 2c) were heavily oxidized (Fig. 2d and e), indicating that the lap was formed before the stud was heat treated (to produce a tensile strength of 1930 to 2070 MPa, or 280 to 300 ksi). The appearance of the stress-corrosion crack near the origin is shown in Fig. 3. (The fractographs in Fig. 3 illustrate the difference in appearance of intergranular fracture and corrosion products when viewed with a scanning electron microscope and with a transmission electron microscope.)

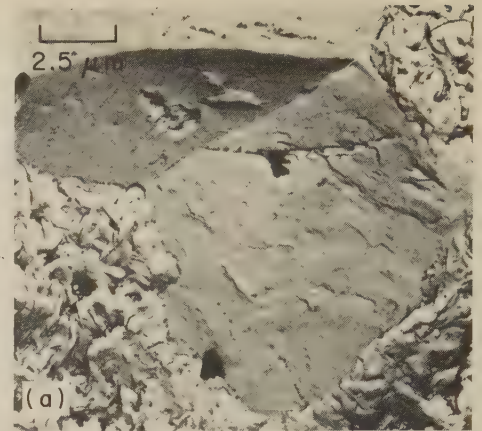
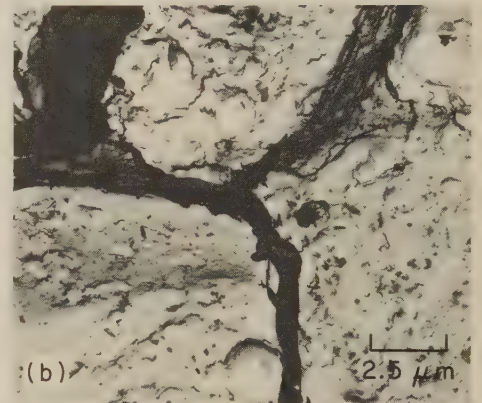
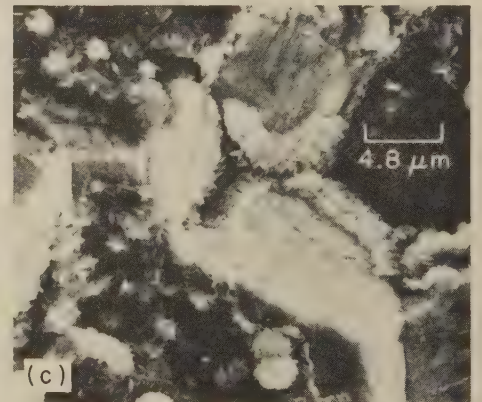
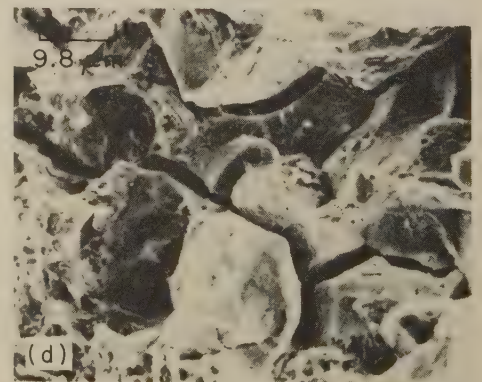
Fig. 3. TEM and SEM views of the stress-corrosion crack in the 300M steel stud for which Fig. 2 shows laps formed during thread rolling. Note intergranular nature of the fracture, corrosion products, and secondary grain-boundary cracks.

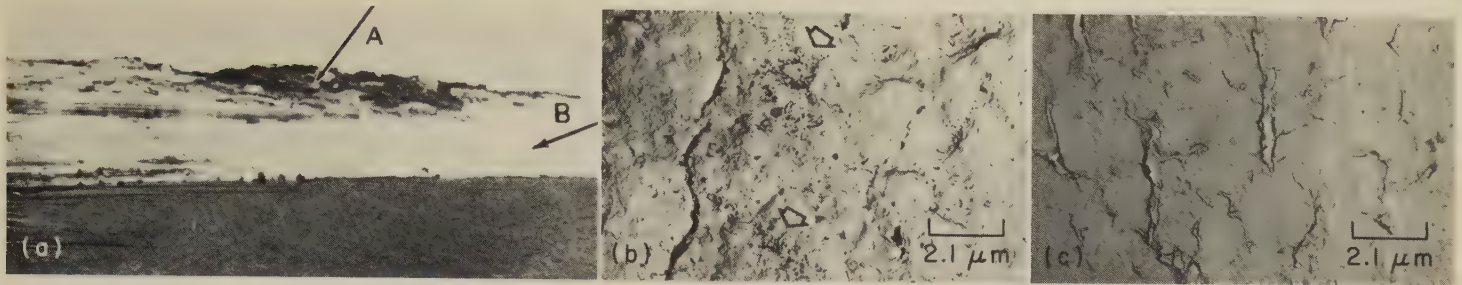
Fig. 4. Surface lap (fold) found in a test specimen from an aluminum alloy 7075-T6 forging. The area that had been folded over had a flat, anomalous appearance. There were some oxides on its surface, as at A in (a) and at the arrows in (b). The light region B in (a) is a saw cut made to facilitate breaking open the lap.

A lap in an aluminum alloy 7075-T6 forging is shown in Fig. 4. This lap was formed when a free surface was folded over during a forging operation. When the fold area was broken open, it appeared anomalous and tarnished, with some indication of oxidation products.

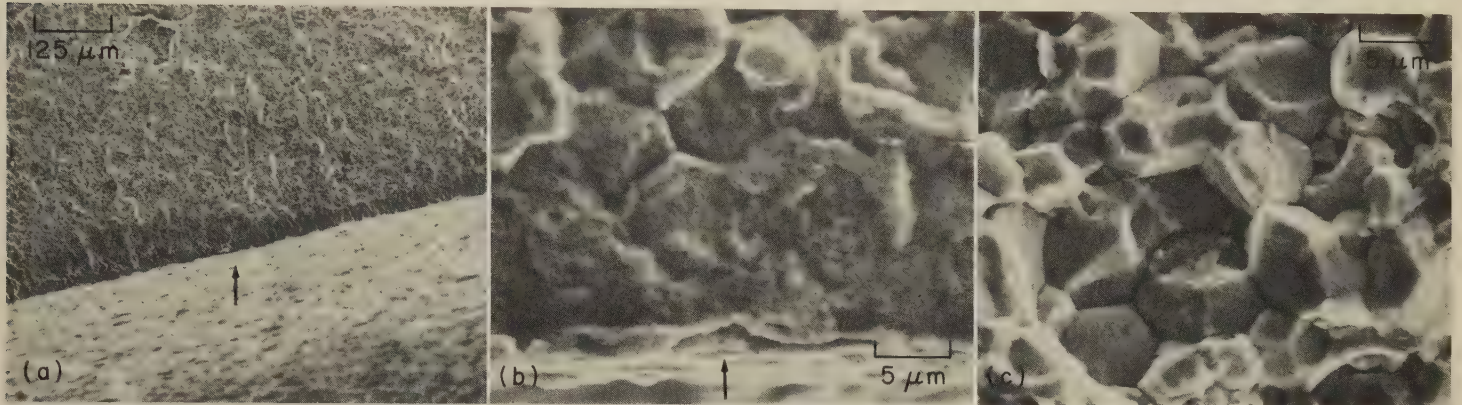
(a) and (b) Remains of an old crack along the edge of the surface of the part (arrows); note dark zone in (a) and extensively corroded separated-grain facets in (b). (c) Clean intergranular portion of crack surface, formed at the time of final fracture.

Fig. 5. Fracture caused by a portion of an old intergranular stress-corrosion crack that was not removed in reworking. Part was made of 4340 steel, heat treated to a tensile strength of 1790 to 1930 MPa (260 to 280 ksi).

The cause and size of a preexisting crack are of primary importance in fracture mechanics, as well as in failure analysis, because of their relationship to the critical crack length for unstable crack growth. Figure 5 shows a fracture in a highly stressed 4340 steel part. A narrow zone of corroded intergranular fracture at the surface of the part is adjoined by a zone of uncorroded intergranular fracture, which in turn is adjoined by a dimpled region. The part had been reworked to remove general corrosion products shortly before fracture. It was concluded that the rework failed to remove about 0.004 in. of a preexisting stress-corrosion crack, which continued to grow after the part was returned to service.

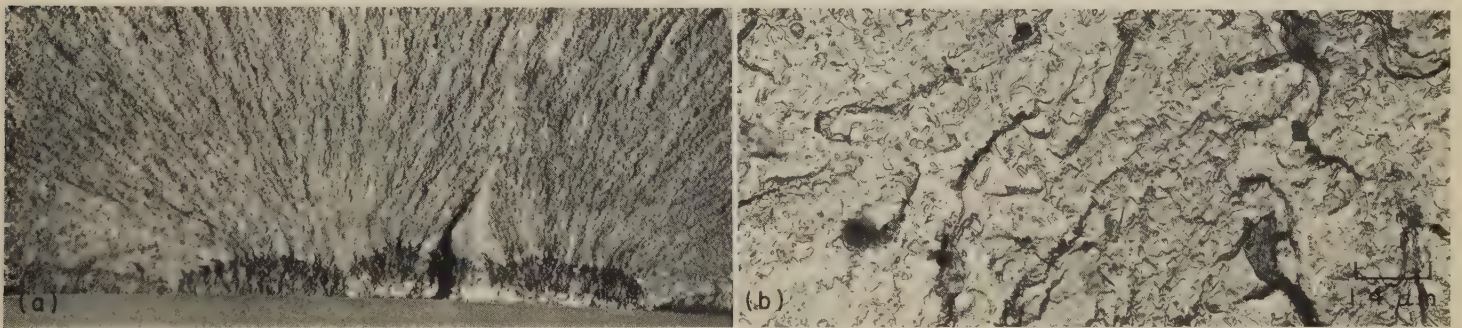
Fig. 6. Preexisting cleavage crack (in light fractograph) that grew from several origins and served as the nucleus for an overload fracture in a 300M steel part that had been heat treated to a tensile strength of 1930 to 2070 MPa (280 to 300 ksi). TEM fractograph shows corrosion products on the fracture surface.

In Fig. 6, the light fractograph shows a preexisting cleavage crack that grew from several origins and served as the nucleus for an overload fracture in a 300M steel part that had been heat treated to a tensile strength of 1930 to 2070 MPa (280 to 300 ksi); the transmission-electron-microscope fractograph in Fig. 6 shows the presence of corrosion products on the fracture surface.

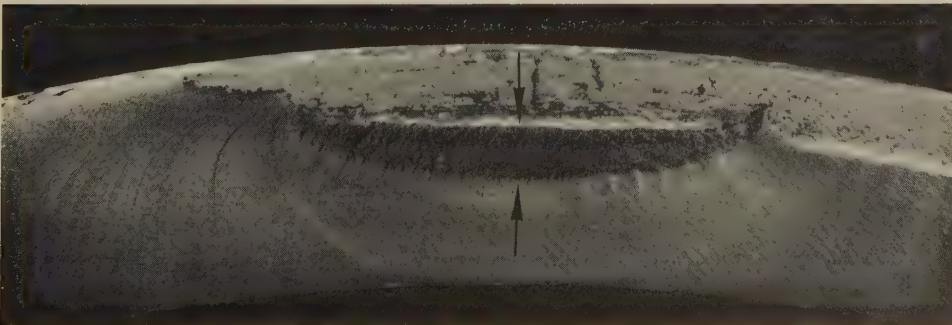
The quenching crack was in the dark, granular area between the two arrows. Metallographic examination showed that this portion of the fracture was intergranular and was covered with a black oxide scale. Oxidation occurred during heat treatment following the quenching operation.

Fig. 7. Fatigue fracture that propagated from a quenching crack in a 4350 steel forging that had a hardness of Rockwell C 35

The heat-treat cracks that most commonly contribute to service fractures are the transformation-stress cracks and quenching cracks that occur in steel. When a heat-treat crack is broken open, the surface of the crack usually has an intercrystalline or intergranular texture. If a crack has been open to an external surface of the part (so that air or other gases could penetrate the crack), it usually has been blackened by oxidation during subsequent tempering treatments or otherwise discolored by exposure to processing or service environments. The appearance of such a crack is shown between the two arrows in Fig. 7.

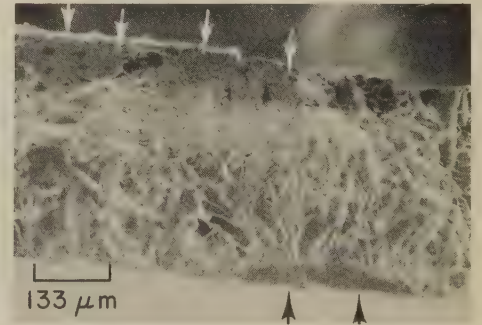
Fig. 8. Fracture in a weld in commercially pure titanium, showing incomplete fusion. Unfused regions, on both surfaces (arrows), served as nuclei of fatigue cracks that developed later under cyclic loading.

Incomplete fusion or inadequate weld penetration can produce a material discontinuity similar to a crack. Subsequent loading can cause the discontinuity to grow, as in Fig. 8, which shows a fracture in a weld in commercially pure titanium that broke by fatigue from crack nuclei, on both surfaces, that resulted from incomplete fusion during welding.

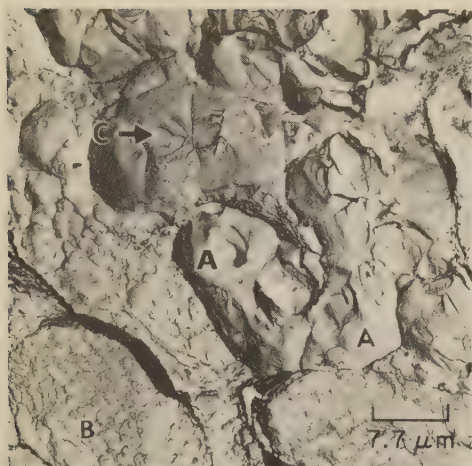
Fig. 9 (at left). Fracture surface of aluminum alloy 2124-T851, showing large dimples (at A's) that initiated at large inclusions (arrow at C). Cracking was produced by relatively little strain. During final, fast fracture, many small dimples (such as at B) formed at fine particles.

parts subjected to cyclic loading. In addition, such inclusions have been identified as initiation sites of ductile fractures in aluminum alloys and steels by several investigators (Ref 1-3). At relatively low strains, microvoids form at inclusions, either by fracture of the inclusion or by decohesion of the matrix-inclusion interface. Figure 9 shows a fracture surface of aluminum alloy 2124-T851 containing

large inclusions (one of which is shown in Fig. 9) that initially fractured to form microvoids. With additional straining, the microvoids grew to the size represented by the large dimples. During final fracture, many small dimples formed at fine particles.

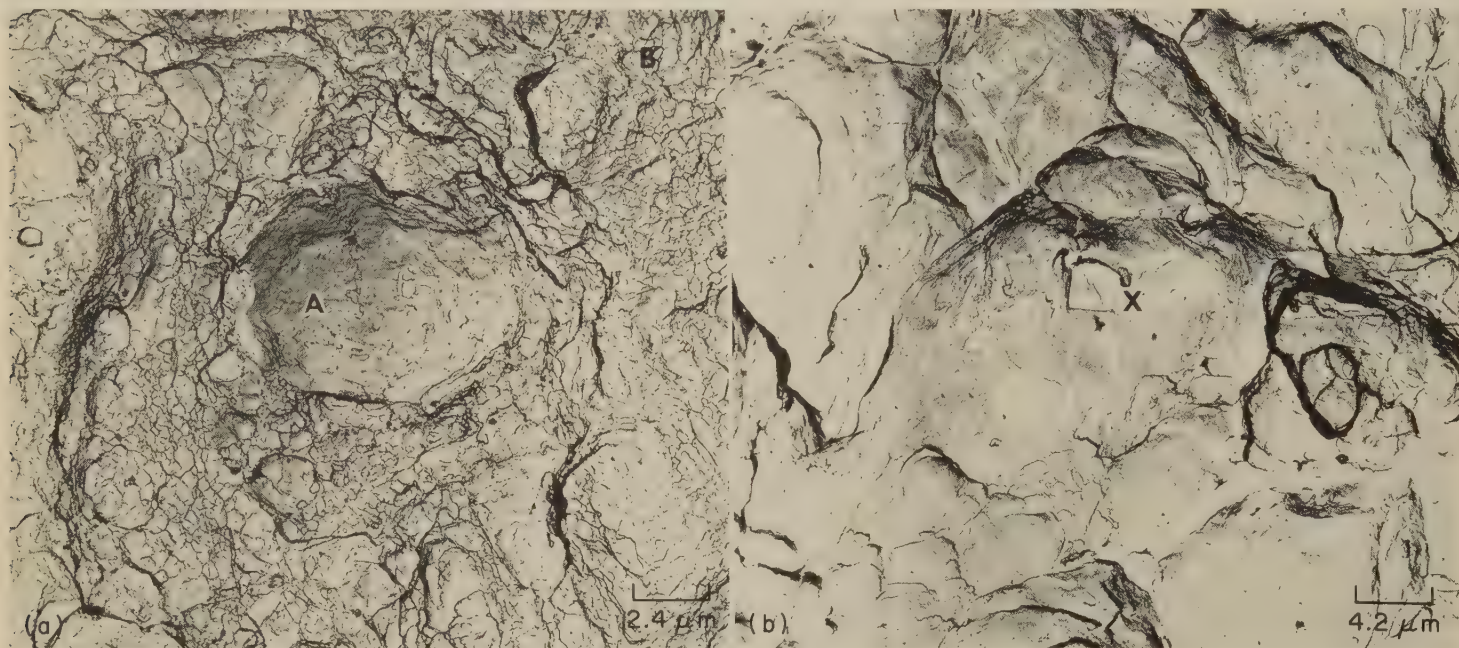
(a) Fractograph taken adjacent to the fatigue crack in a plane-strain fracture-toughness specimen of commercial-quality 4340 steel. At A is a large dimple; B indicates a region of small dimples. Note similarity of appearance of this fracture surface to that in area B of the fracture surface shown in Fig. 9.

(b) Fractograph taken adjacent to the fatigue crack in a plane-strain fracture-toughness specimen of high-quality 18% Ni maraging steel. At X is a cleaved particle of titanium carbonitride at the bottom of a large dimple. Note the absence of small dimples, such as are present in region B in (a).

Fig. 10. Comparison of dimple formation at inclusions in 4340 steel and in 18% Ni maraging steel

The ductile-fracture mechanism for 4340 steel is similar to that for aluminum. The mechanism for 18% Ni maraging steel differs in that a relatively few large microvoids grow until they meet in final fracture and form dimples; there is no formation of small dimples. This difference is shown in Fig. 10.

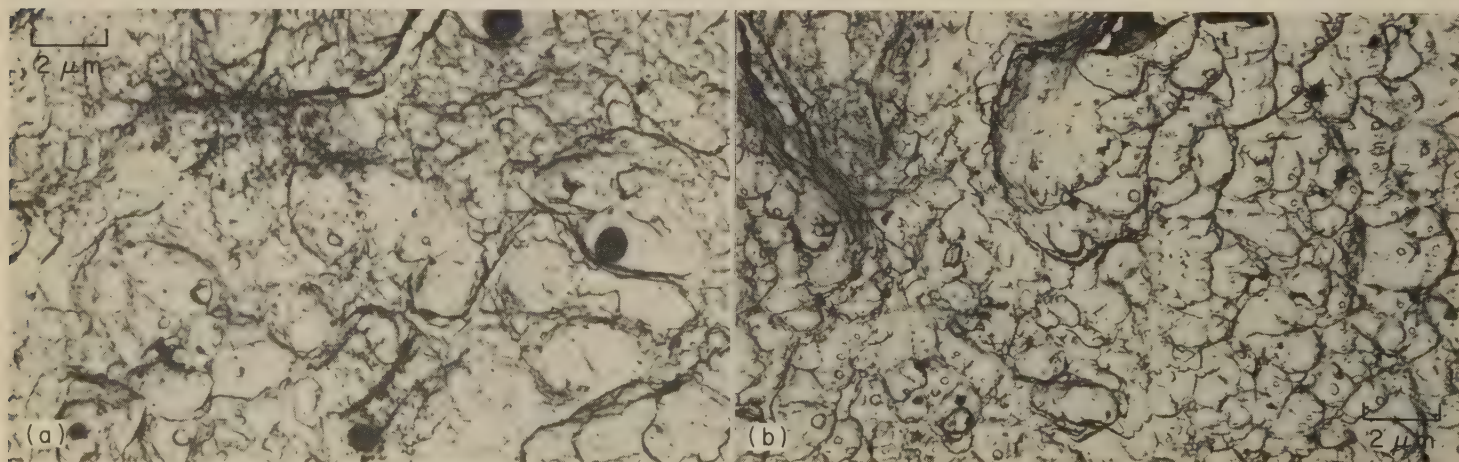
(a) Specimen from heat containing 0.049% sulfur. Large, shallow dimples were nucleated by relatively coarse sulfide particles. (b) Specimen from heat containing 0.008% sulfur. Many small dimples were nucleated by small carbide particles, but there were relatively few large dimples derived from sulfide particles.

Fig. 11. Fracture surfaces of two plane-strain fracture-toughness specimens from experimental heats of martensitic 0.45% C nickel-chromium-molybdenum steel containing different amounts of sulfur. Both specimens were tempered at 427 C (800 F).

Figure 11 shows typical fracture-surface characteristics produced by plane-strain fracture-toughness tests of two experimental heats of quenched-and-tem-

pered 0.45% C nickel-chromium-molybdenum steel with extremes of sulfur content. Because high-purity materials and carefully controlled melting procedures were used, both heats were remarkably free of nonmetallic inclusions, except for sulfide particles (Ref 1). The fracture surfaces of specimens from both heats of steel consisted predominantly of equiaxed dimples. The fracture surface of the 0.049% S steel (see Fig. 11a) consists of many large, shallow dimples that appear to have been nucleated during the fracture process by numerous, relatively coarse sulfide particles. In contrast, the fracture surface of the 0.008% S steel

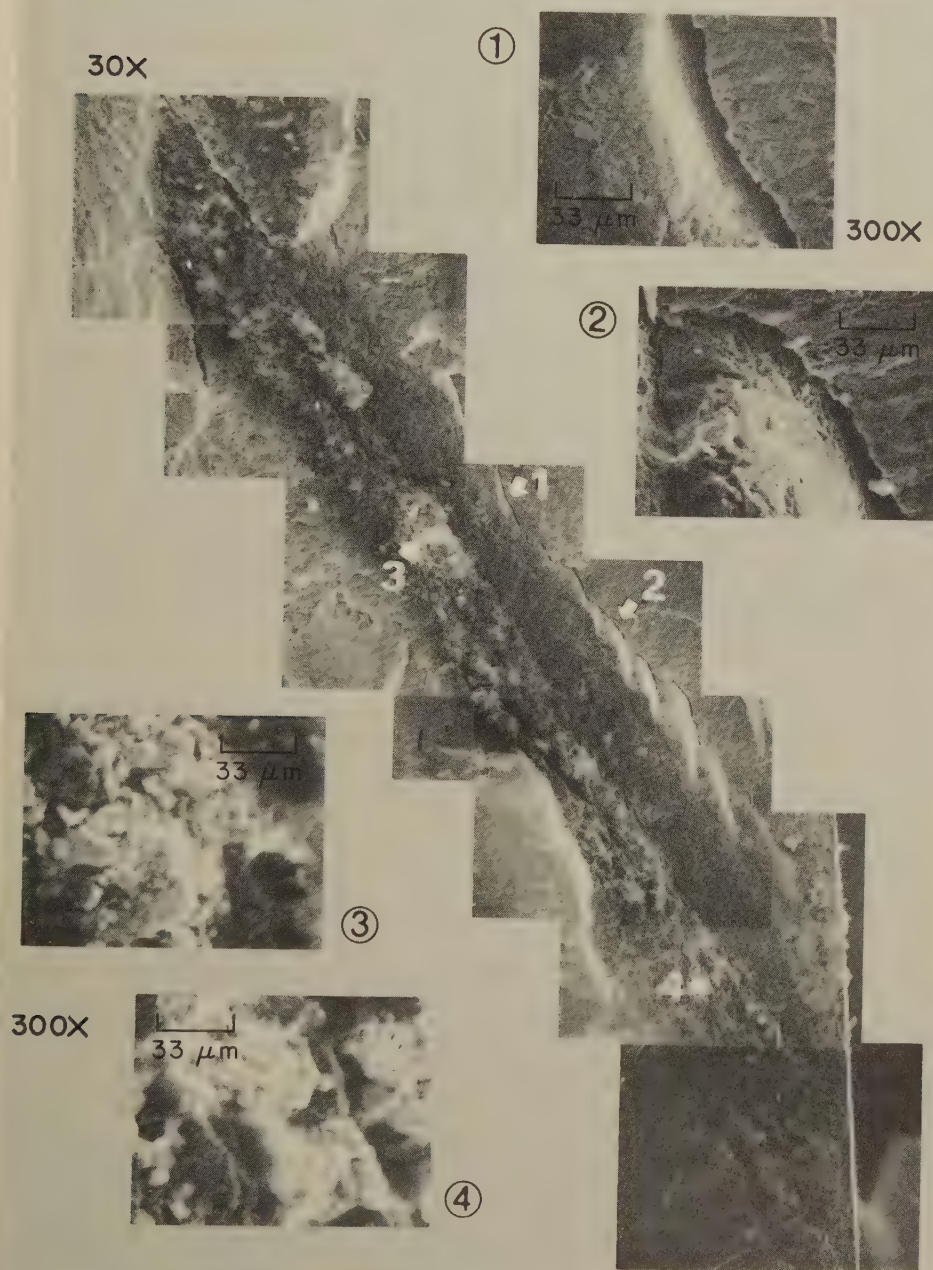
The diagonal view is a composite of several fractographs showing a very large inclusion, which was a fragment of the pouring-ladle firebrick lining. Fractographs 1, 2, 3 and 4 are higher-magnification views of areas indicated respectively by arrows 1, 2, 3 and 4 in the diagonal view.

Fig. 12. Inclusion in a surface of a service fracture in a case-hardened 9310 steel forging

The very large inclusion shown in the SEM fractographs in Fig. 12 was found in the fracture surface of a case-hardened 9310 steel forging that broke in service. X-ray analysis of the inclusion led to the deduction that it was a fragment of the firebrick lining of the pouring ladle.

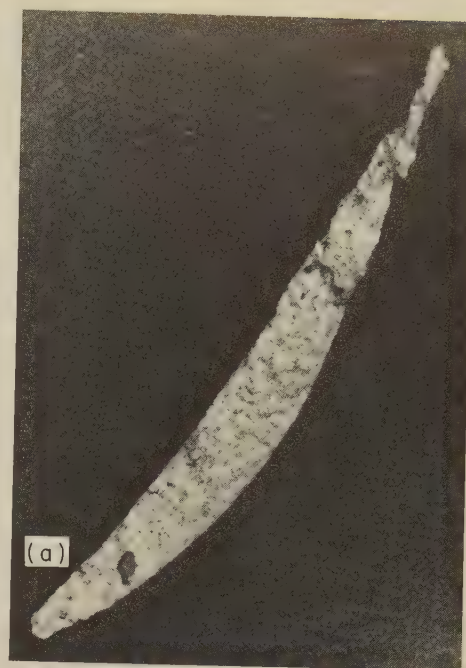
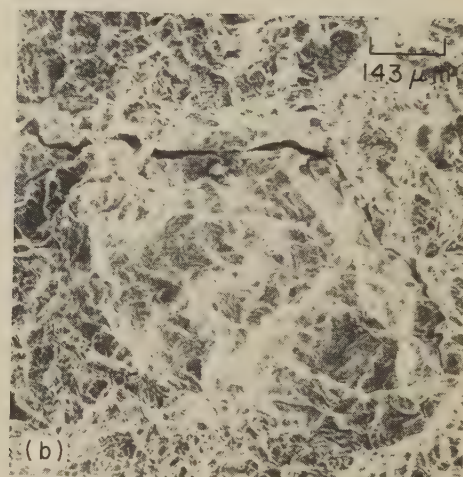
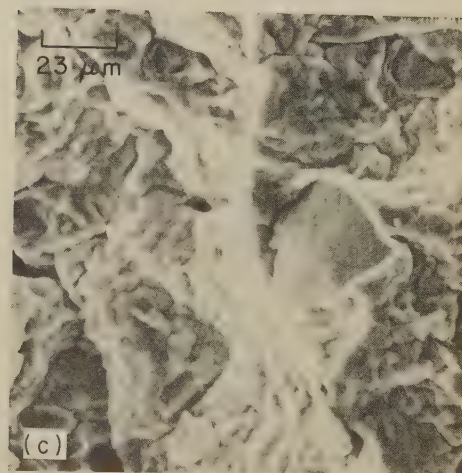
(a) Over-all view of the fracture surface, showing a large inclusion (dark) near the tip of the blade. (b) and (c) Decohesion at the interfaces between the inclusion and the aluminum matrix.

Fig. 13. Fracture surface of a cast aluminum alloy A357-T6 air-turbine blade

Figure 13 shows a large inclusion in a fracture surface of a cast aluminum alloy A357-T6 blade of a small, high-speed air turbine and two views of the fracture-surface features around this inclusion.

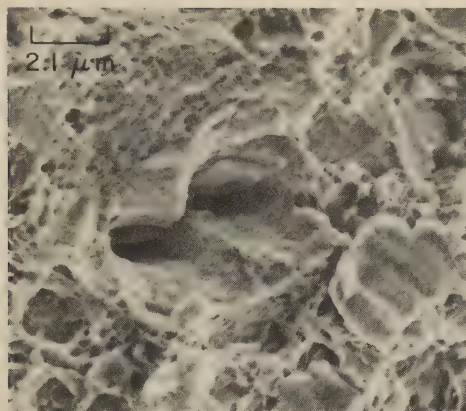
SEM fractograph 4700×
Fig. 14. Fracture surface of 4340 steel heat treated to a tensile strength of 1790 to 1930 MPa (260 to 280 ksi), showing deep dimples containing the inclusions that initiated them (J. Kilpatrick, Delta Air Lines)

Figure 14 shows the fracture features associated with inclusions in 4340 steel with a tensile strength of 1790 to 1930 MPa (260 to 280 ksi).

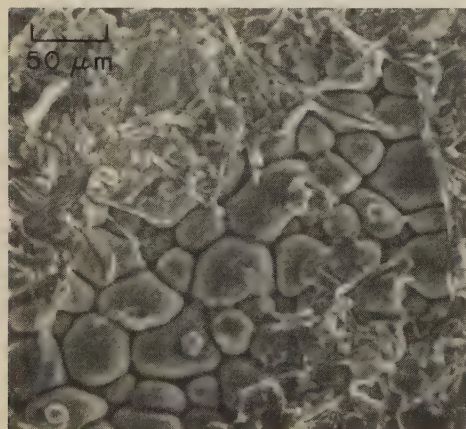
SEM fractograph 200×
Fig. 15. Halide-flux inclusion (rounded granules) in the joint between an actuator and an attachment bracket of aluminum alloy 6061 that were joined by dip brazing using an Al-12Si brazing alloy

Entrapped flux in a brazed joint can effectively reduce the strength of the brazement and also can create a long-term corrosion problem. An aluminum alloy 6061 attachment bracket was dip brazed to an actuator of the same alloy in a flux consisting of a mixture of sodium, potassium and lithium halides that conformed to AMS 3415 and 3416, and the assembly was heat treated to the T6 temper after brazing. Here the flux inclusion, shown in Fig. 15, reduced the cross section of the joint, and an overload fracture occurred in the Al-12Si brazing alloy.
